Cosmos Club | Washington, DC Historic Architecture

The Cosmos Club is a significant contributing building to the Dupont Circle Historic District, the Massachusetts Avenue Historic District, and is individually listed on the National Register of Historic Places. The historic core of the building is known as the Townsend Mansion and was constructed from 1899 to 1901 by Carrère and Hastings.

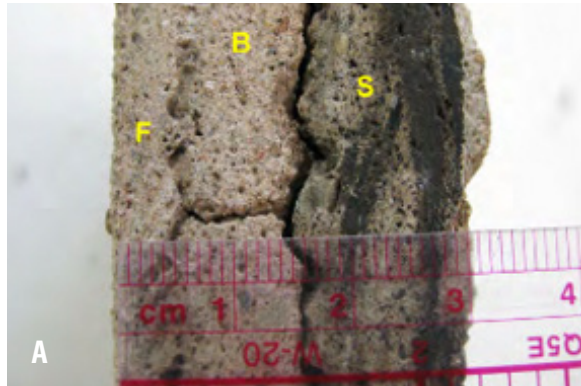
A. Analysis: Cross section of stucco sample showing three-layer composition with F-Finish Coat, B-Brown Coat, S-Scratch Coat.

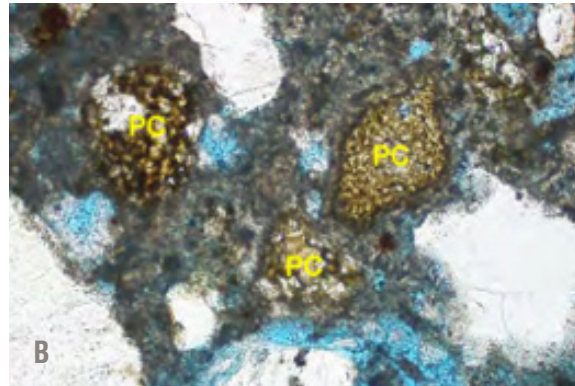
B. Analysis: Petrographic analysis of polished cross section using polarized light microscope. Portland cement residuals marked with PC.

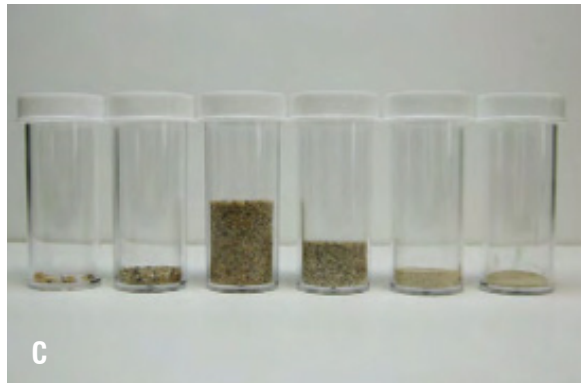
C. Analysis: Grain-size analysis of extracted aggregate using sieves.

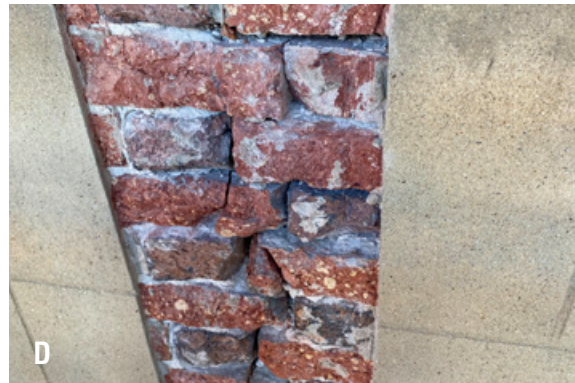
D. Mockup: Area of stucco to be patched. Notice roughened flemish bond brick behind existing stucco. Mrs. Townsend installed stucco over the flemish bond brick shortly after construction according to building permits.

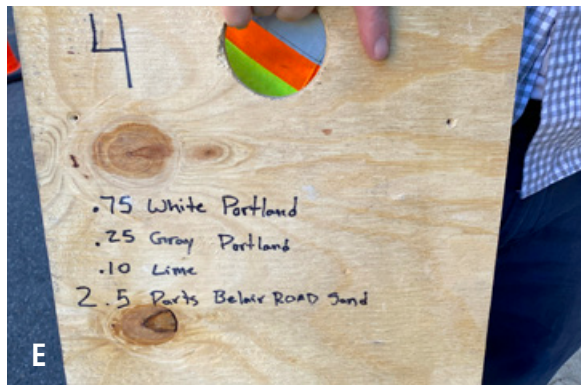
E. Mockup: Stepped stucco sample board showing texture and layers.

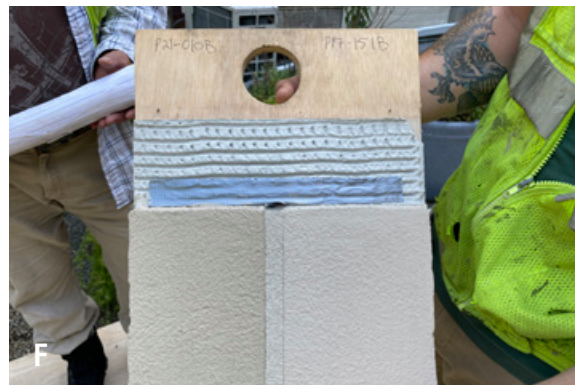
F. Mockup: Composition of finish coat based on results of analysis: 1:0.1:2.5 parts cement:lime:sand.

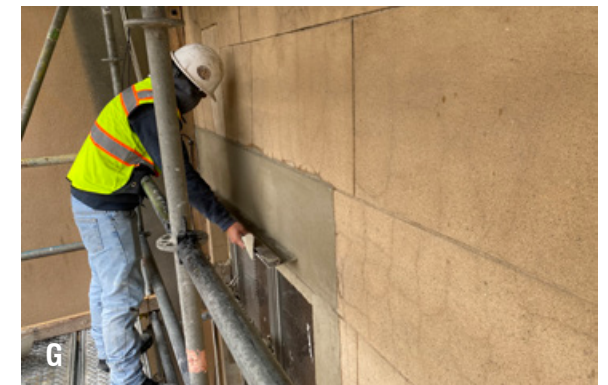
G. Installation: Mason installs cement stucco to infill areas of damage.
